Hudson-Cippa-Wolf Ranch
Sorento Road
Sacramento
Sacramento County
California

HABS No. CA-2656

HISTORIC AMERICAN BUILDINGS SURVEY

HUDSON-CIPPA-WOLF RANCH

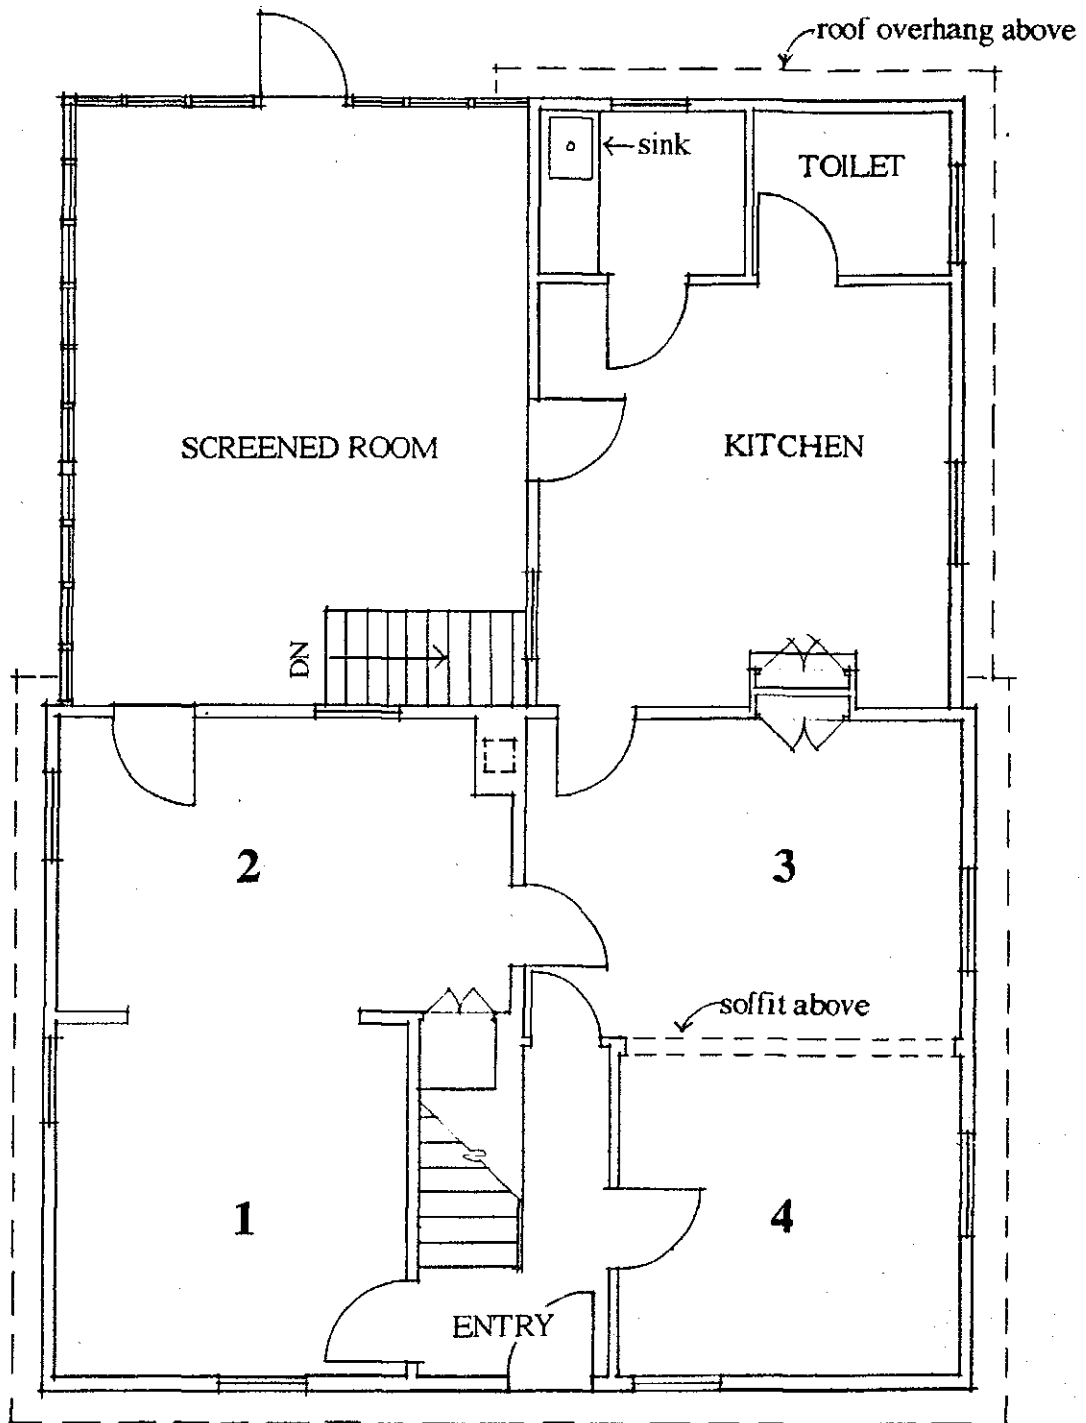
MAIN HOUSE
FIRST FLOOR PLAN

The house was in poor condition before it was demolished — almost every window was broken, the outside porches had collapsed, the interior stairway and railing had almost completely collapsed.

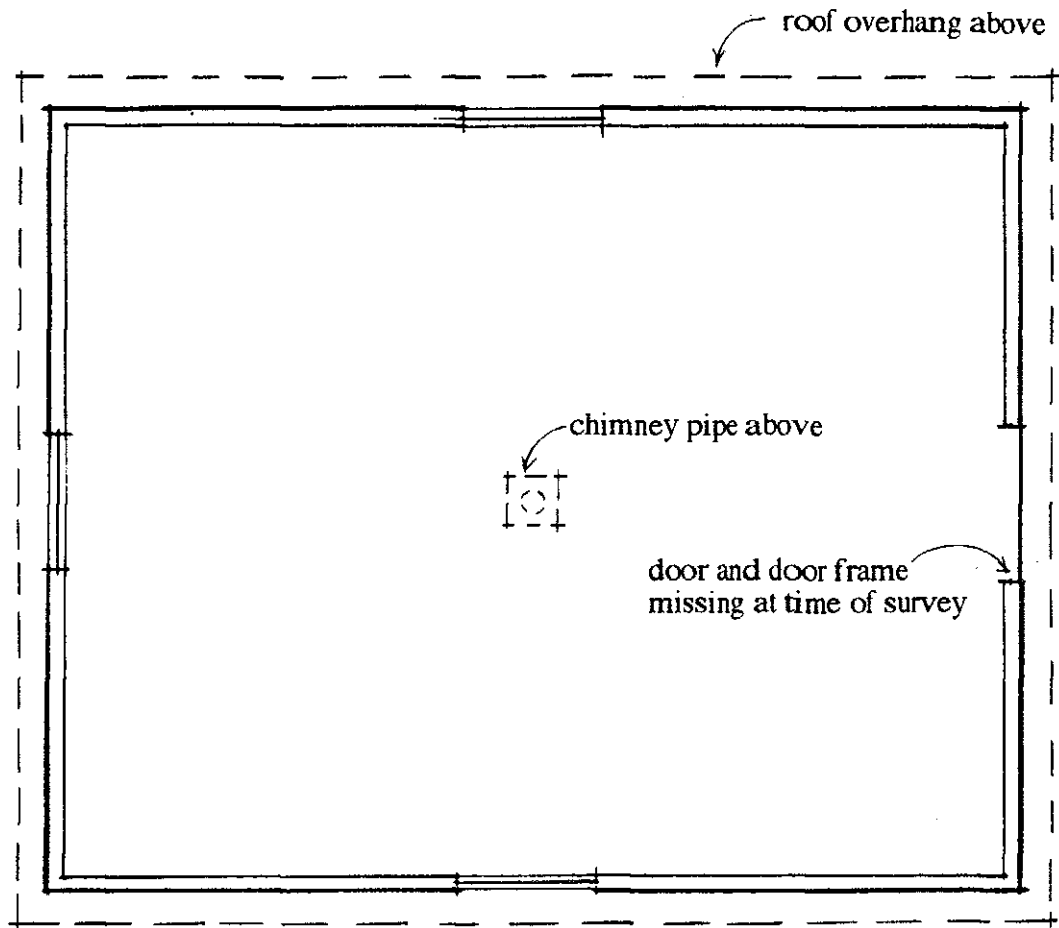
BUNKHOUSE
PLAN

The building was in poor condition — exterior siding was missing at the base of the building, exposing the studs; window glass was mostly gone; and once boarded-up openings were broken open again. Although in poor condition, this bunkhouse retained enough of its essential features of plan, structure, and materials to convey its historic character and retain integrity.

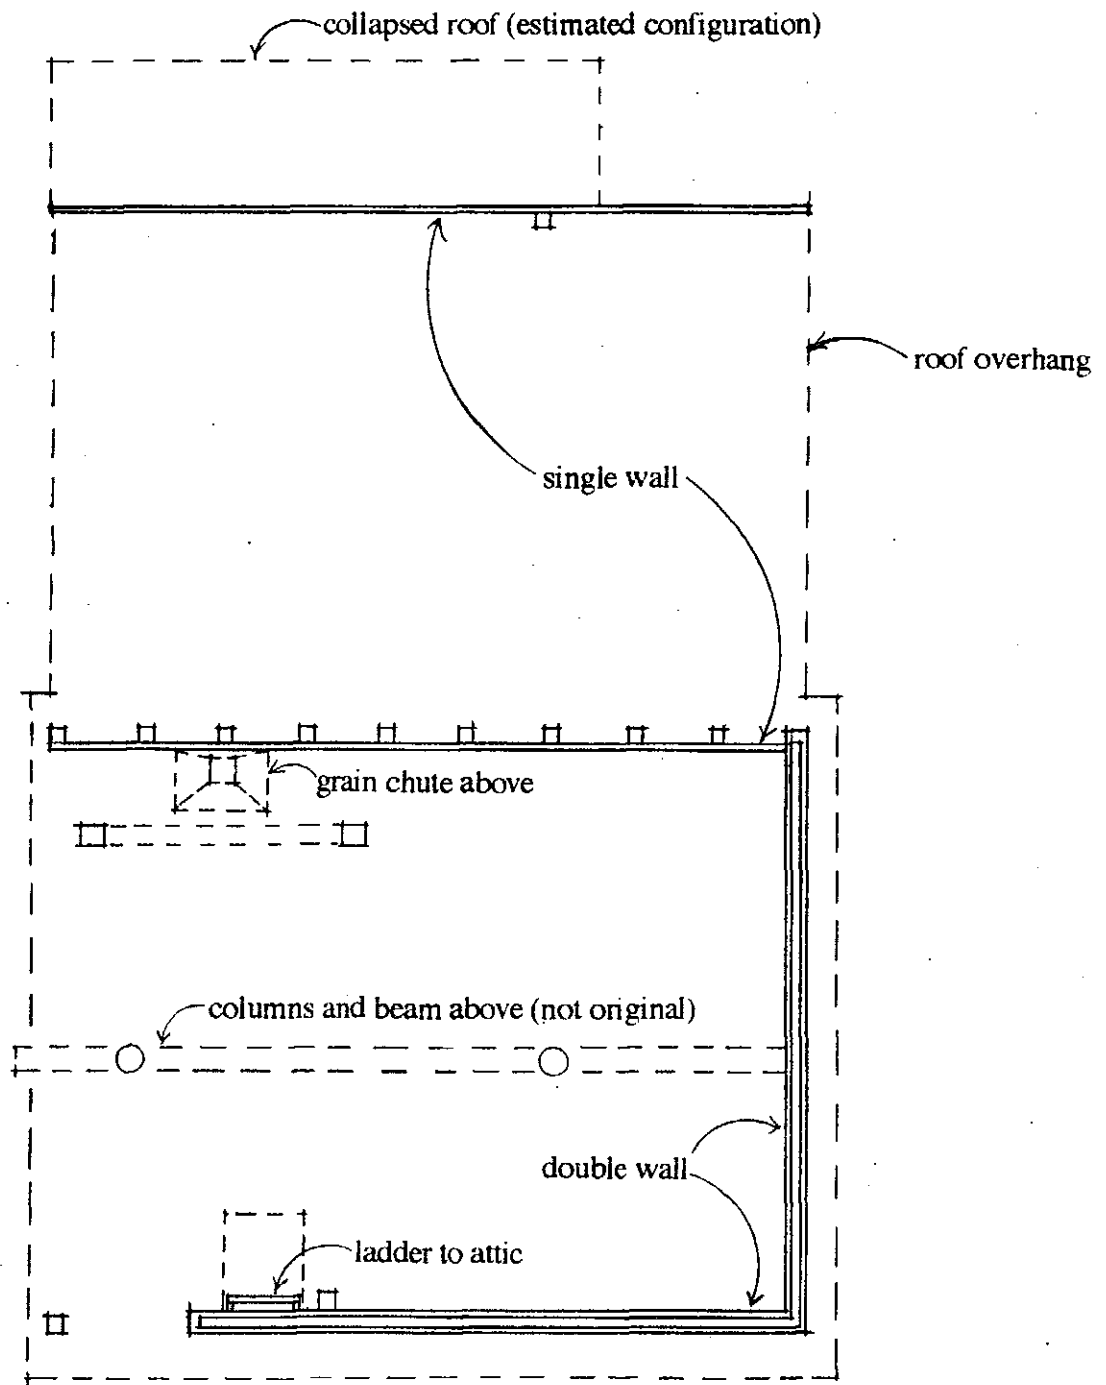
GRANARY
GROUND FLOOR PLAN

The north side shed extension was clad in vertical siding of irregular width, attached with square nails and therefore probably added before 1900. The south side extension was similar in character. These extensions were flimsy constructions which were in poor condition.

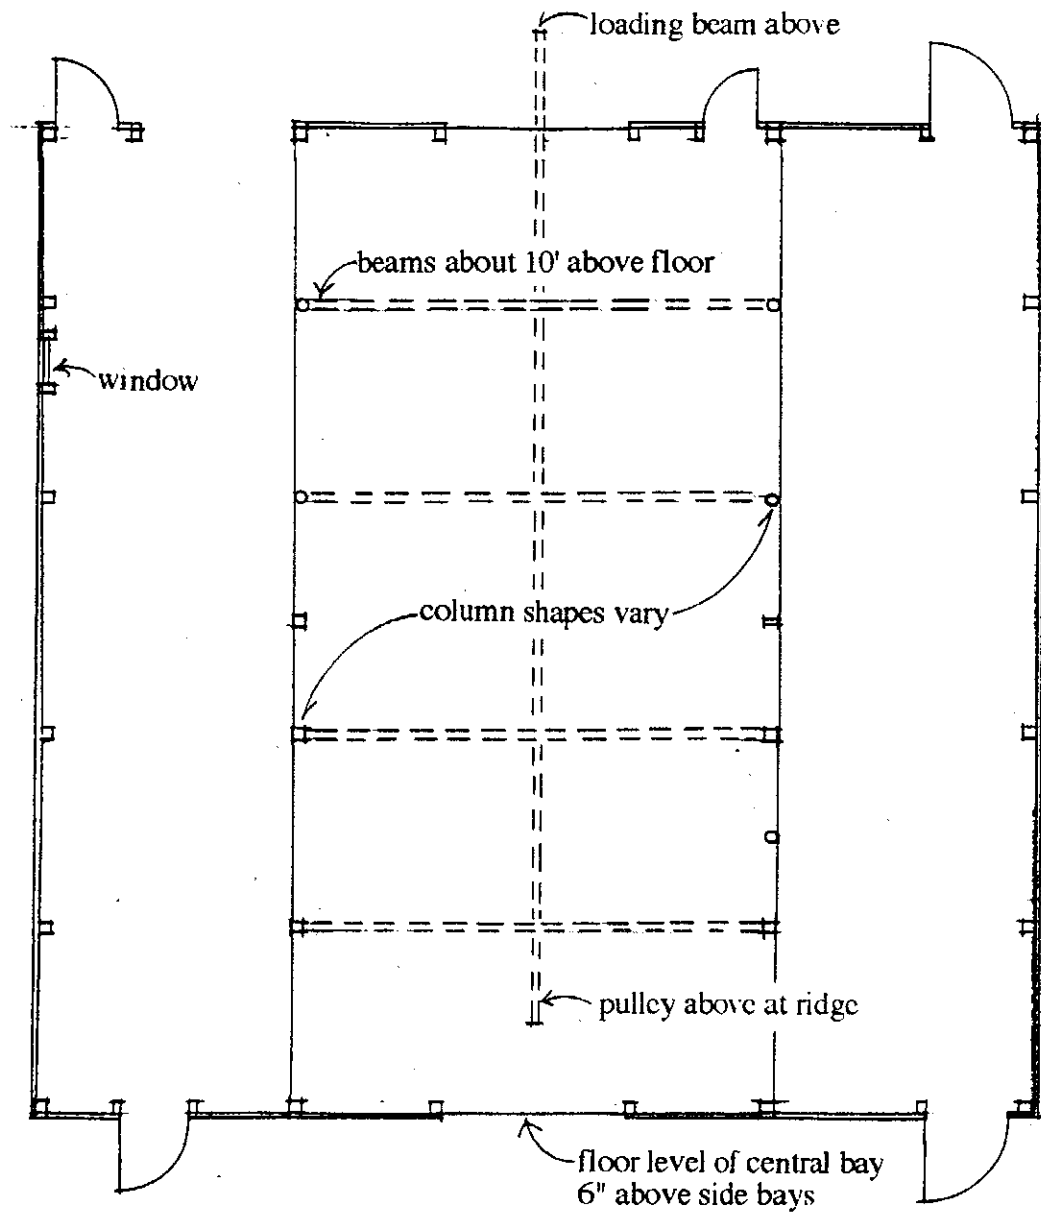
MILK BARN
PLAN

The milk barn was in poor condition, supported in part by a number of steel cables to prevent its collapse. Although nearly falling down, it retained its original features of plan, structure, and materials in sufficient measure to represent the type.

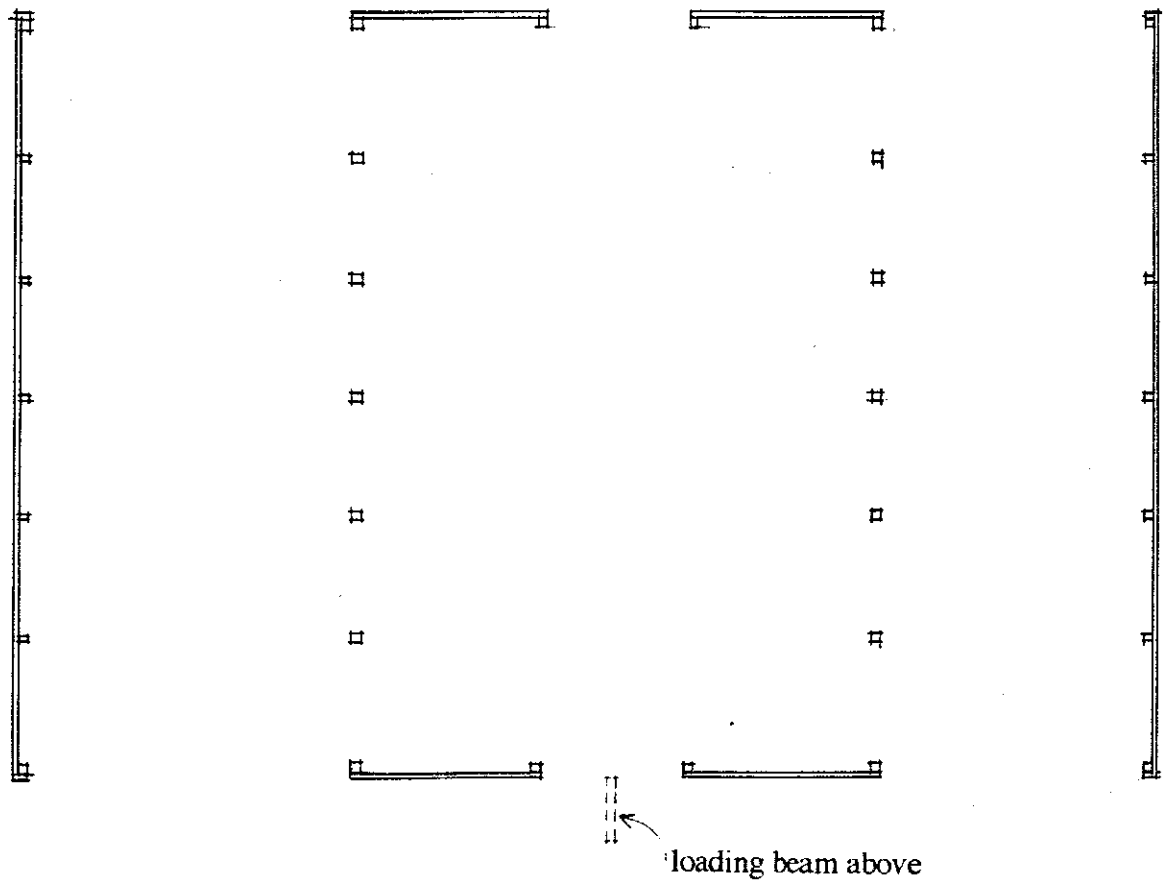
Although in poor condition, this barn retained enough of its essential characteristics of plan, structure and materials to serve as a representative of its type. Many of its changes represent historic changes in use rather than a loss of integrity.

Note: The extremely dilapidated and modified condition of the building may have obscured some of the structure.
